3. East Tennessee Technology Park

3.1 Description of Site and Operations

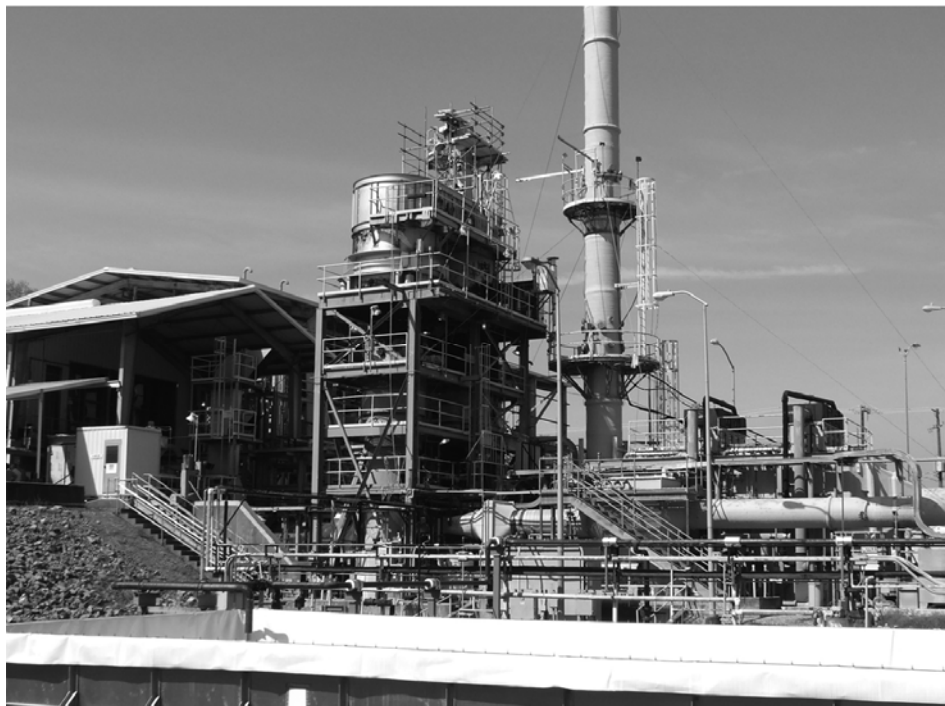
Fig. 3.4. TSCA Incinerator.

Prior to December 2, 2009, and the subsequent ceasing of operations, ETTP airborne discharges from the TSCA Incinerator were generated while treating solid and liquid wastes from residual contamination, waste storage and treatment operations, site remediation and demolition activities, and site maintenance support activities. The primary source of radiological emissions at ETTP was the TSCA Incinerator, which was the major active airborne radionuclide emission source at ETTP regulated under 40 CFR 61 National Emission Standards for Hazardous Air Pollutants: Department of Energy facilities (rad NESHAP). The TSCA Incinerator was equipped with extensive exhaust gas pollution control equipment, enabling it to operate in regulatory compliance with both CAA and the Tennessee air pollution control regulations.

The TSCA Incinerator was the largest permitted operating nonradionuclide air emissions source and the largest source of criteria pollutant emissions such as nitrogen oxides (NO_x) and carbon monoxide (CO) for all sources listed in the DOE ETTP Major Source Operating Permit application. Total NO_x emissions for 2009 were 15.7 tons (31,347 lb). Total CO emissions were 3.9 tons (7,837 lb). Emissions of all nonradiological regulated air pollutants from TSCA Incinerator operations are noted in Figs. 3.7–3.9. In the three categories of data presented, emissions are compared with EPA ambient air quality standards and are identified as criteria pollutants (including particulate matter [PM]); hazardous air pollutants as regulated under 40 CFR 63, Subpart EEE, “National Emission Standards for Hazardous Air Pollutants for Source Categories (Maximum Achievable Control Technology [MACT])” and other pollutants regulated under Permit No. 957808I, as issued by TDEC. Each data point on these figures represents the accumulated pollutant emissions for a continuous 12-month period. Table 3.3 lists all TSCA Incinerator emission limits that include those pollutant parameters associated with Figs. 3.7–3.9. All graphical information is based on the allowable rates identified in the TSCA Incinerator air permit. Actual emissions are conservatively calculated using removal efficiencies as determined from the most recent permit-required air test or other previously approved compliance demonstration test.

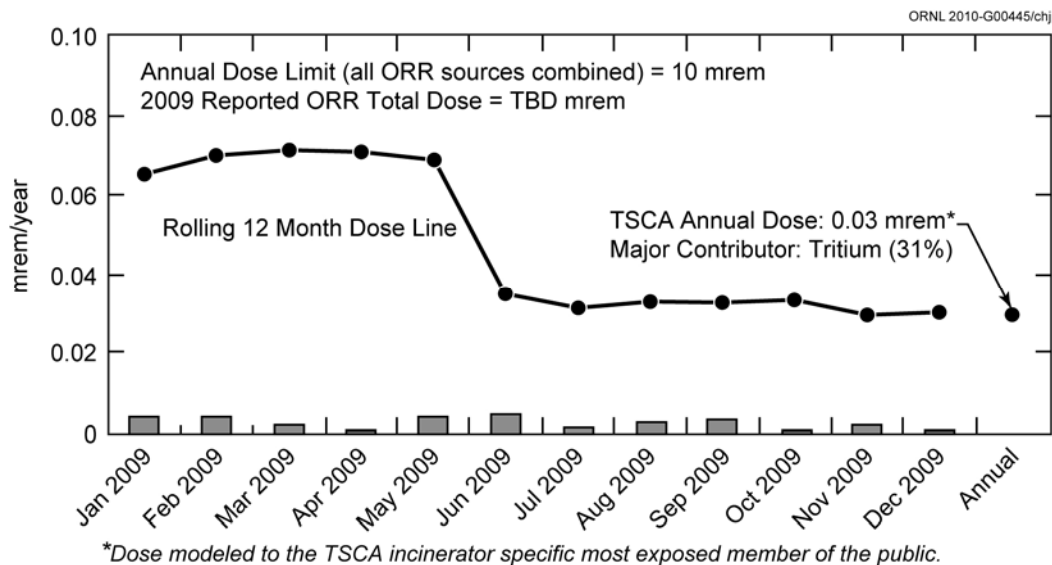
Fig. 3.5. Dose from TSCA Incinerator operations.

Both sources are far below the 10-mrem/year effective dose (ED), which is the rad NESHAP regulatory limit and the applicable standard for combined radionuclide emissions from all ORR facilities. Emissions from these sources as well as all other ETTP minor stationary sources of radionuclides are included in the annual dose assessment report submitted Jun 24, 2010 as required under Radioactive NESHAP (Rad-NESHAP) regulations.

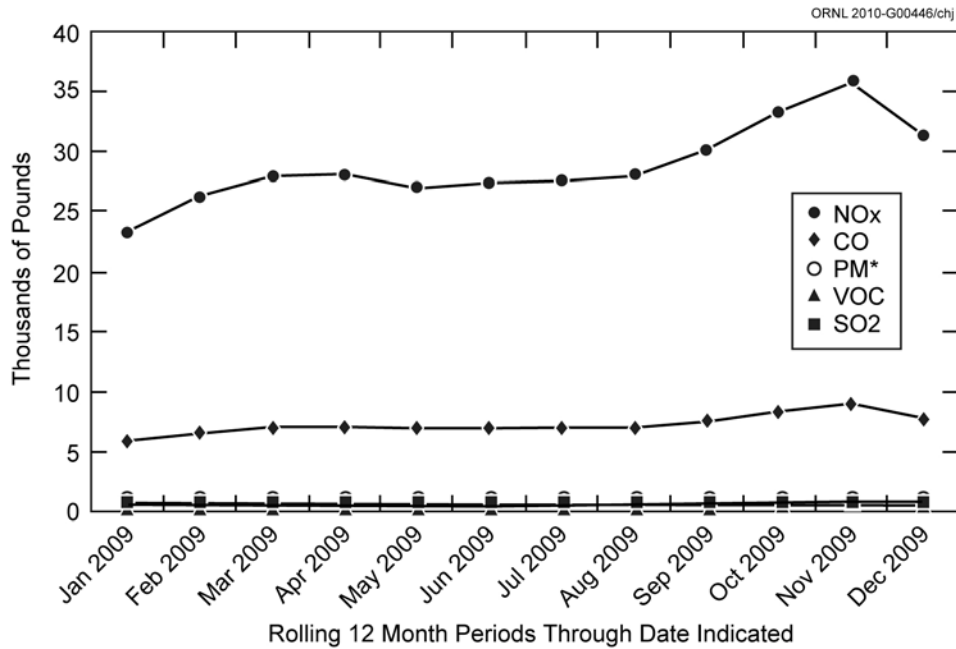
*PM is also regulated under 40 CFR 63, Subpart EEE (MACT).

Fig. 3.7. TSCA Incinerator criteria pollutant emissions.

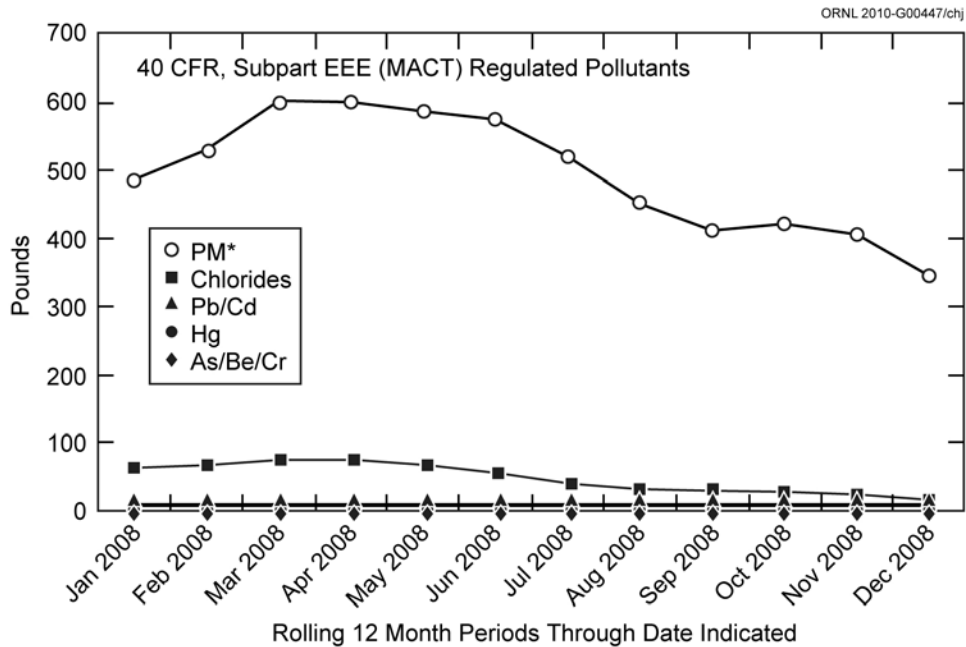
*PM is also regulated as a criteria pollutant.

Fig. 3.8. TSCA Incinerator pollutant emissions regulated under maximum achievable control technology standards.

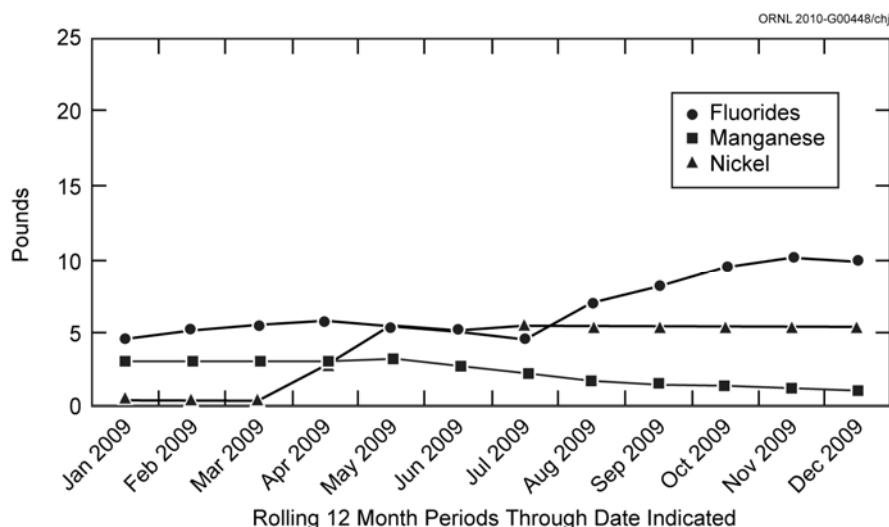
Fig. 3.9. TSCA Incinerator other regulated pollutant emissions.

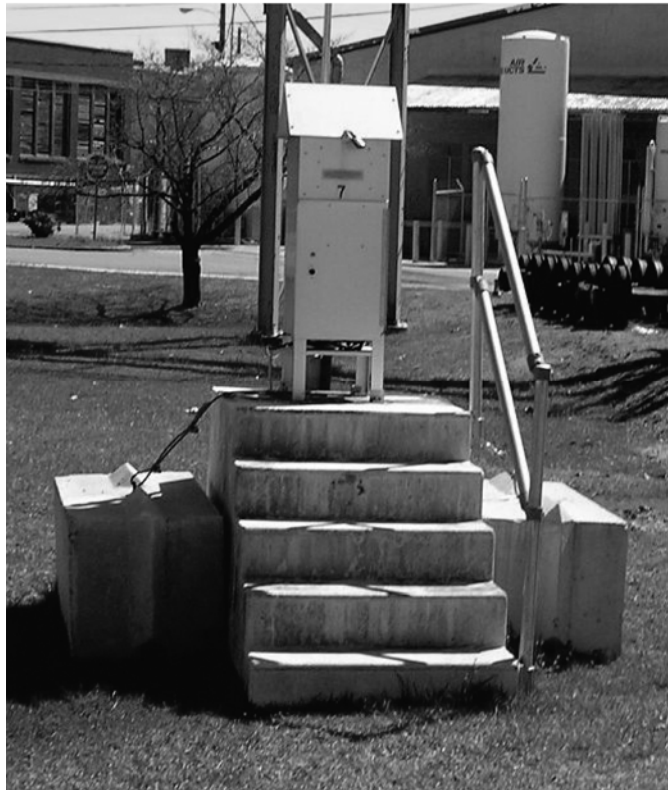
Fig. 3.10. Ambient air monitoring station.

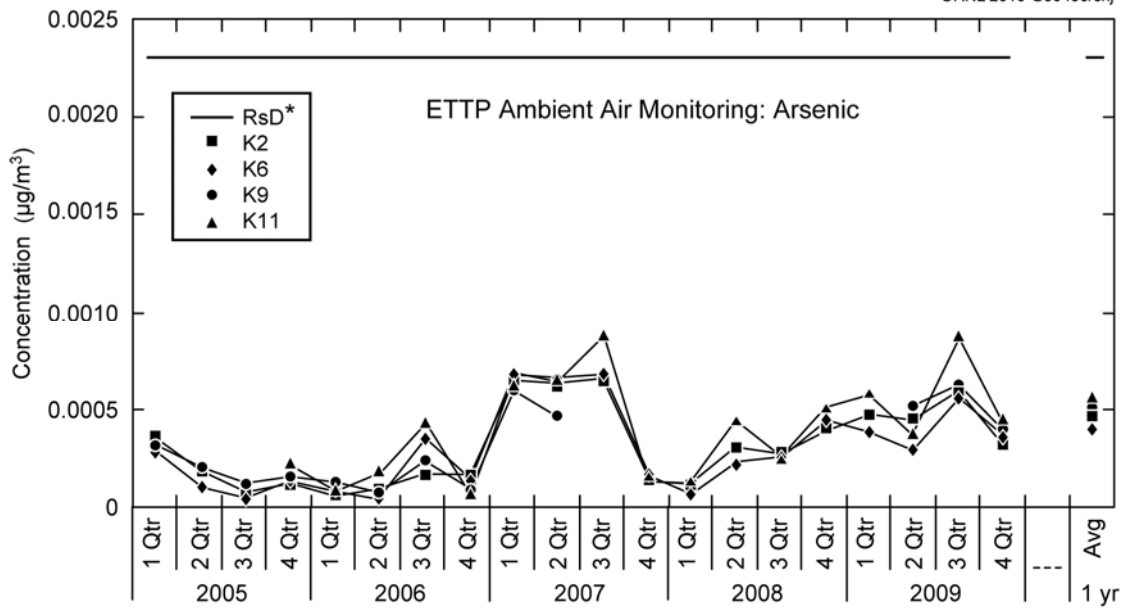
* RsD - Risk-specific dose. EPA acceptable RsD for arsenic = 0.0023 µg/m³.

Fig. 3.11. Arsenic monitoring results: 5-year history through 2009.

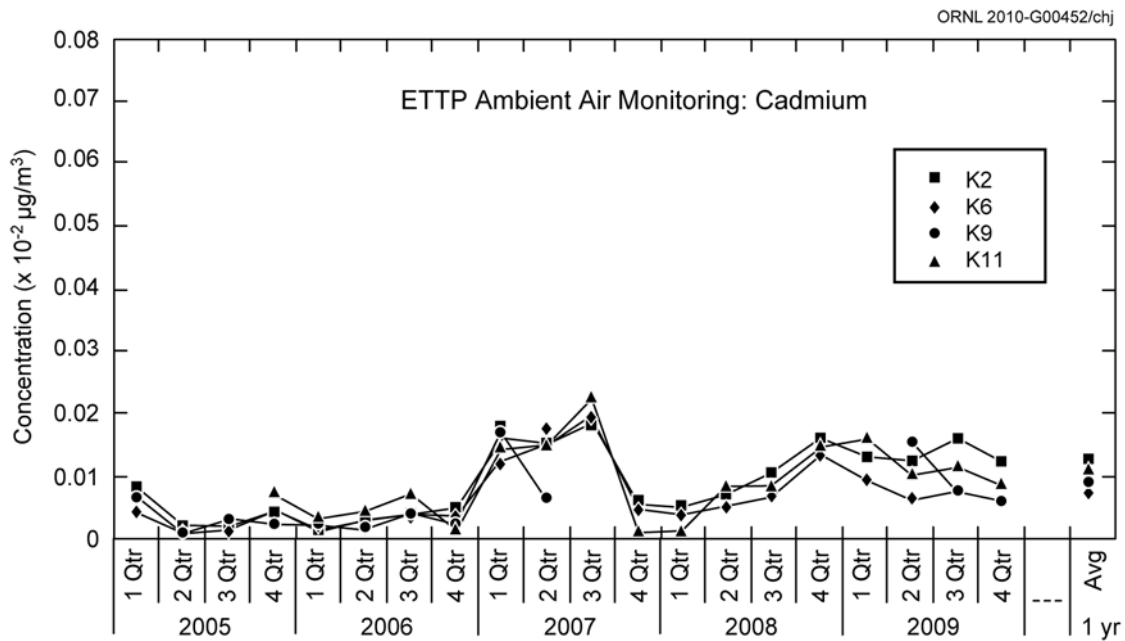
* RsD - Risk-specific dose. EPA acceptable RsD for cadmium = $0.0056 \mu\text{g}/\text{m}^3$.

Fig. 3.13. Cadmium monitoring results: 5-year history through 2009.

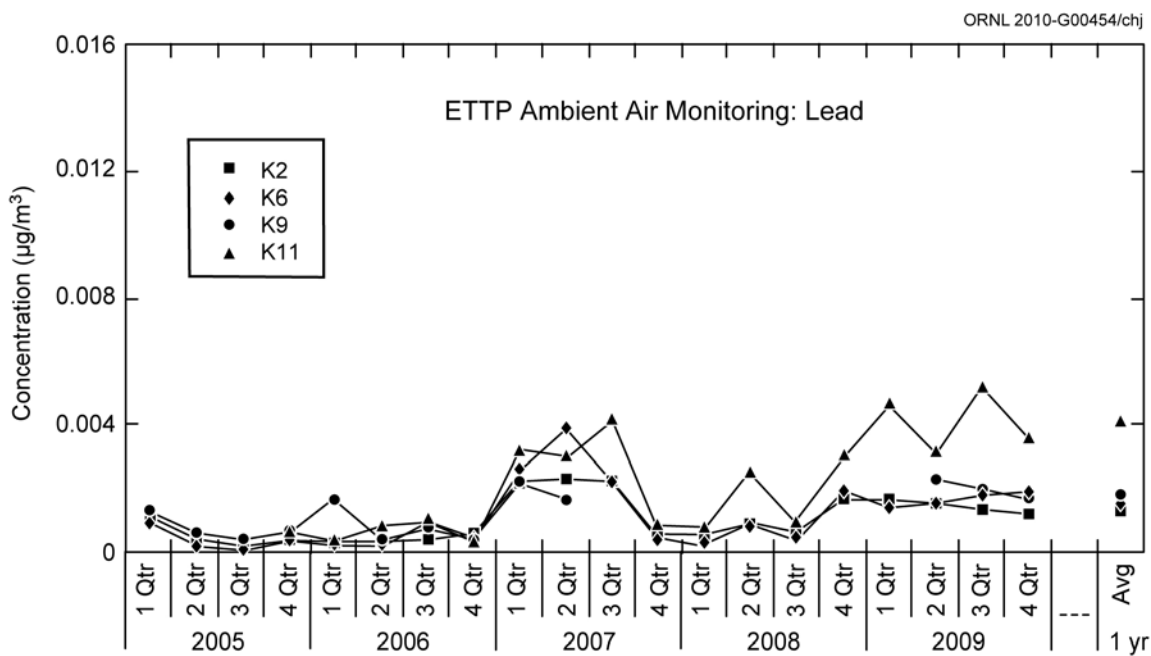
*National Ambient Air Quality Standard (NAAQS) for lead = 1.5 $\mu\text{g}/\text{m}^3$ per quarter through Sept. 2008.
 †NAAQS for lead = 0.15 $\mu\text{g}/\text{m}^3$ per quarter beginning Oct. 2008.

Fig. 3.15. Lead monitoring results: 5-year history through 2009.

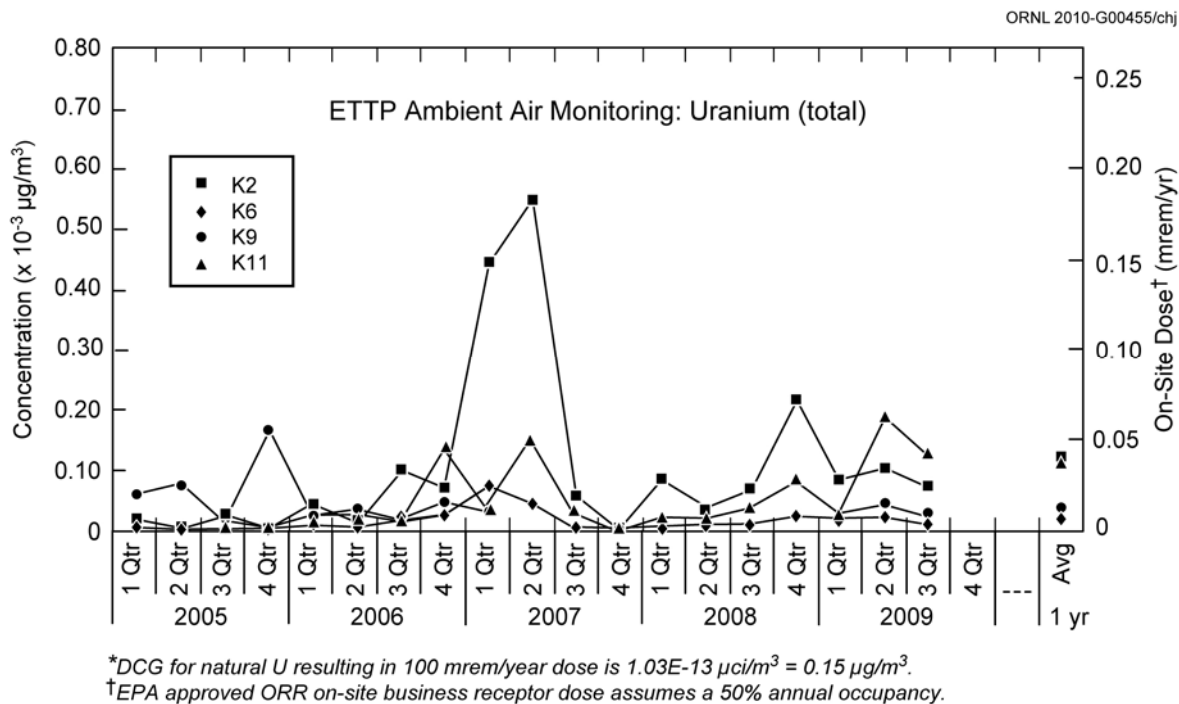
Fig. 3.16. Uranium metal monitoring results: 5-year history through 2009.

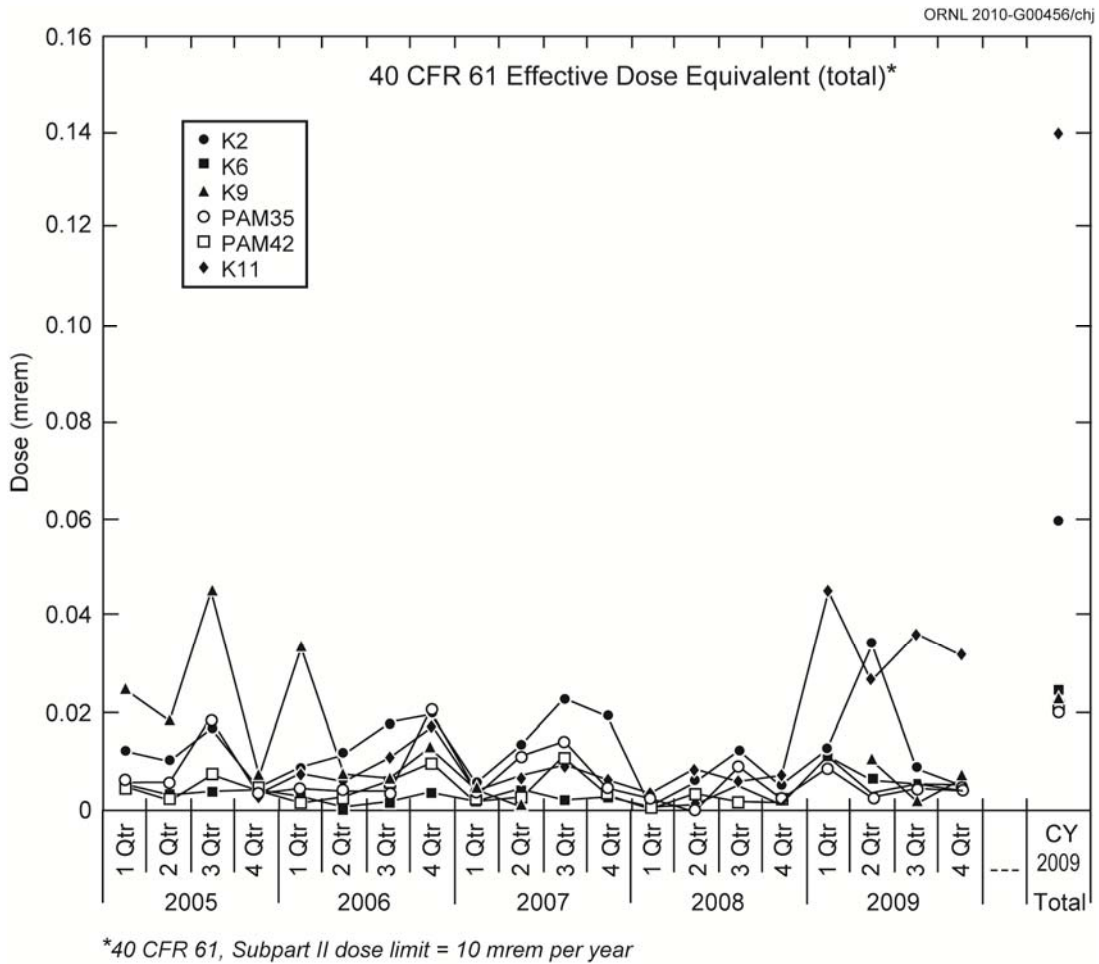
Fig. 3.17. Radionuclide monitoring results: 5-year history through 2009.

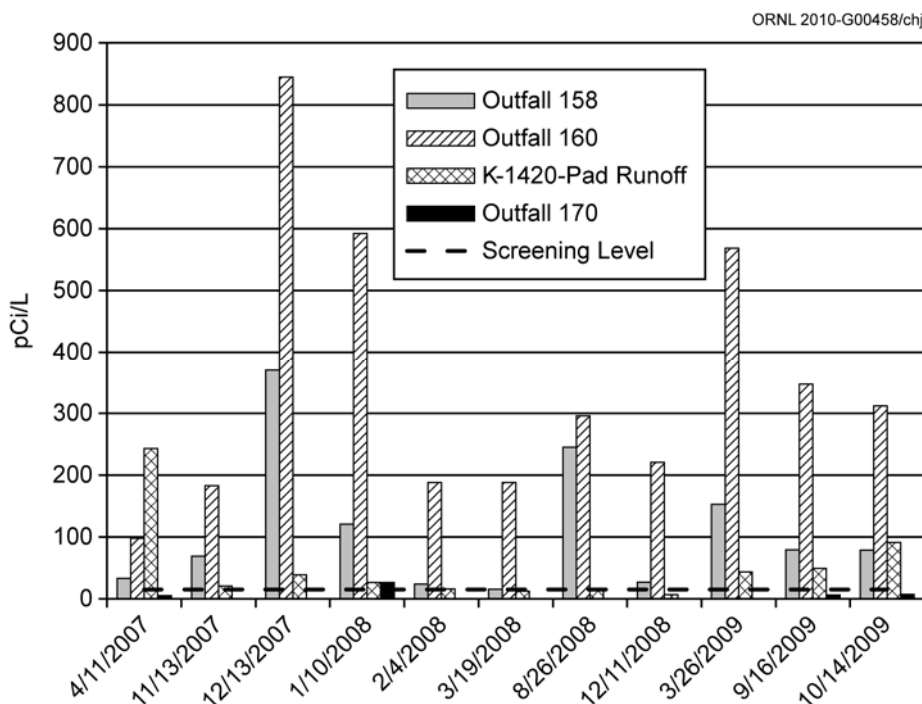
Fig. 3.19. Relative levels of gross alpha radioactivity in discharges from outfalls 158, 160, 170 and the K-1420 pad.

In 2009, gross alpha radiation was detected in the discharges from storm water outfalls 158 and 160 and the K-1420 pad at levels greater than 15 pCi/L, which is the screening level developed from the maximum contaminant level (MCL) established by the Safe Drinking Water Act. Gross alpha radiation for outfall 170 was below screening level. Compared to historical data (Fig. 3.19 and Tables 3.13, 3.14, 3.15, and 3.16), the results for the 2009 SWP3 sampling are representative of the levels of gross alpha radiation normally found at these locations.

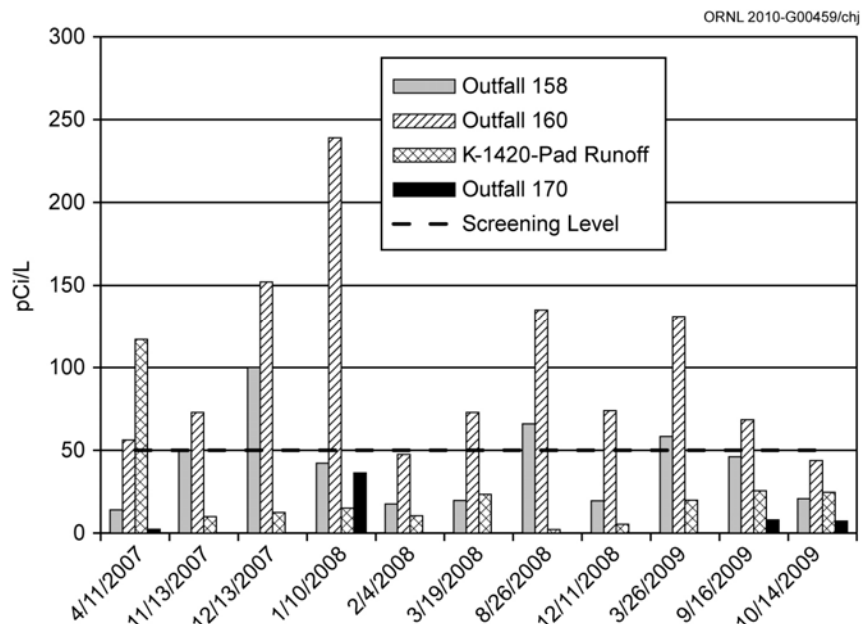
Fig. 3.20. Relative levels of gross beta radioactivity in discharges from outfalls 158, 160, 170 and the K-1420 pad.

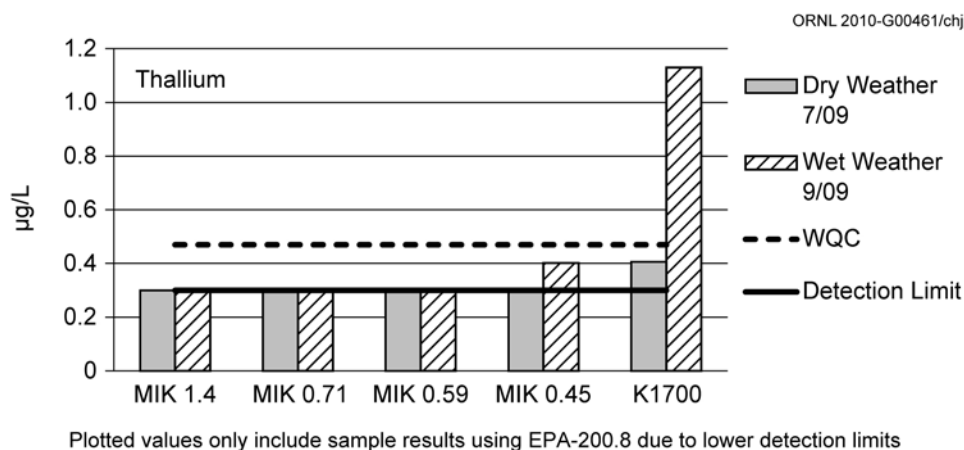
Fig. 3.36. Thallium results from Mitchell Branch investigation sampling event.

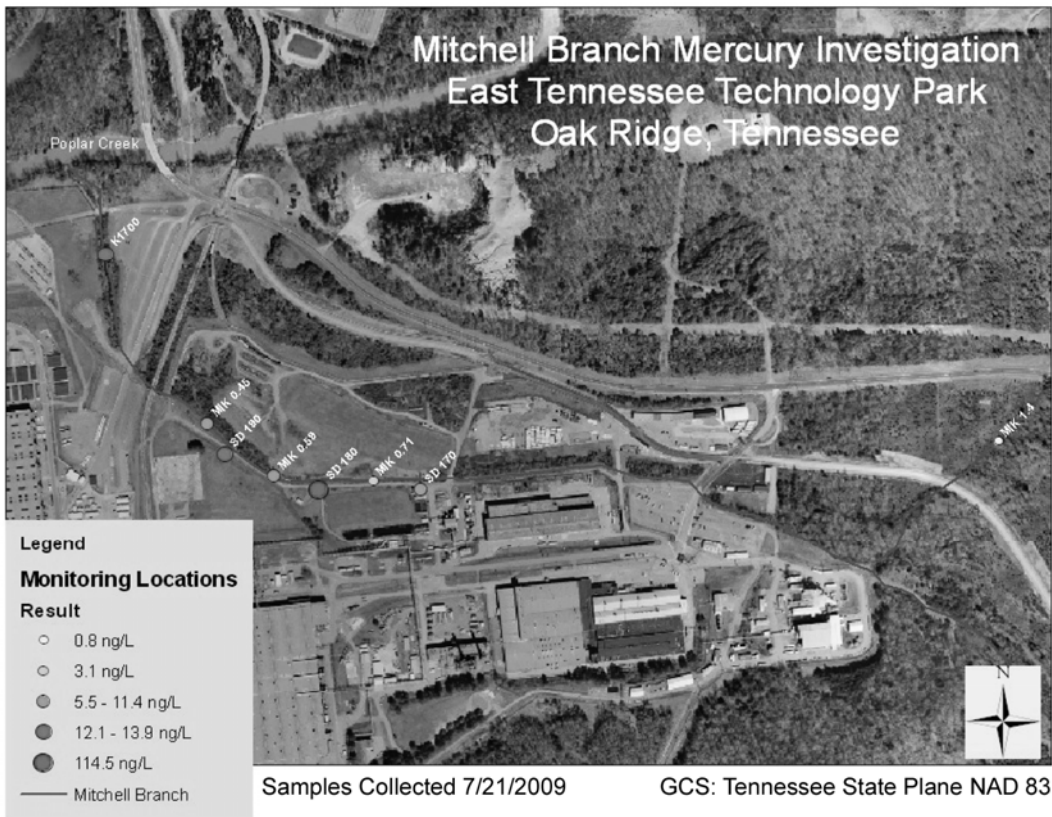
Fig. 3.39. Aerial photo of Mitchell Branch mercury sampling locations and results.

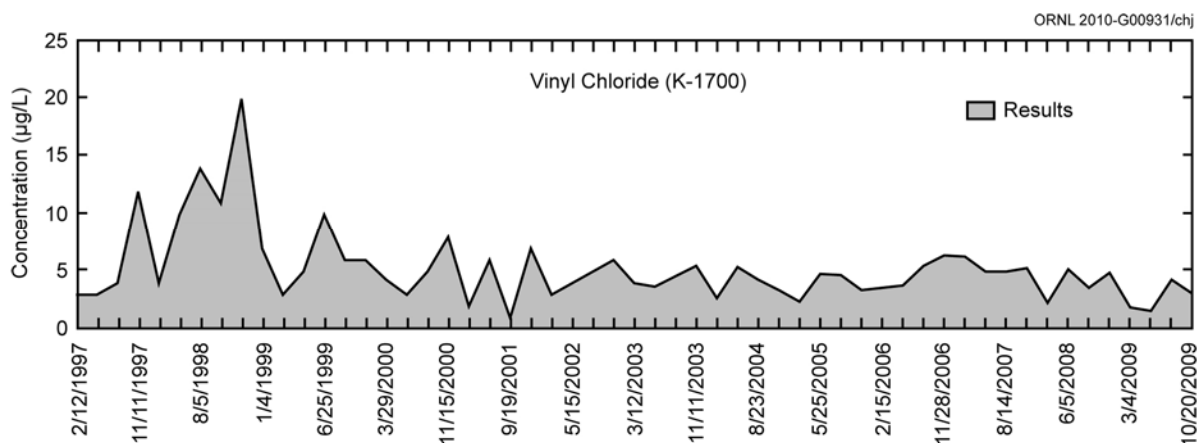
Fig. 3.45. Vinyl chloride concentrations at K-1700.

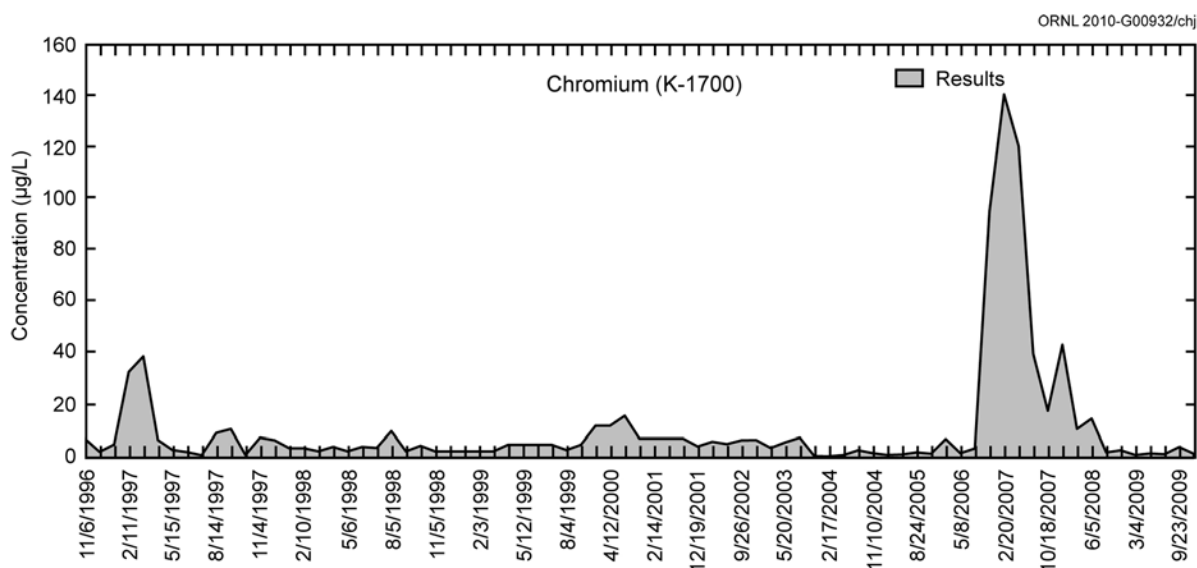
Fig. 3.46. Total chromium concentrations at K-1700.

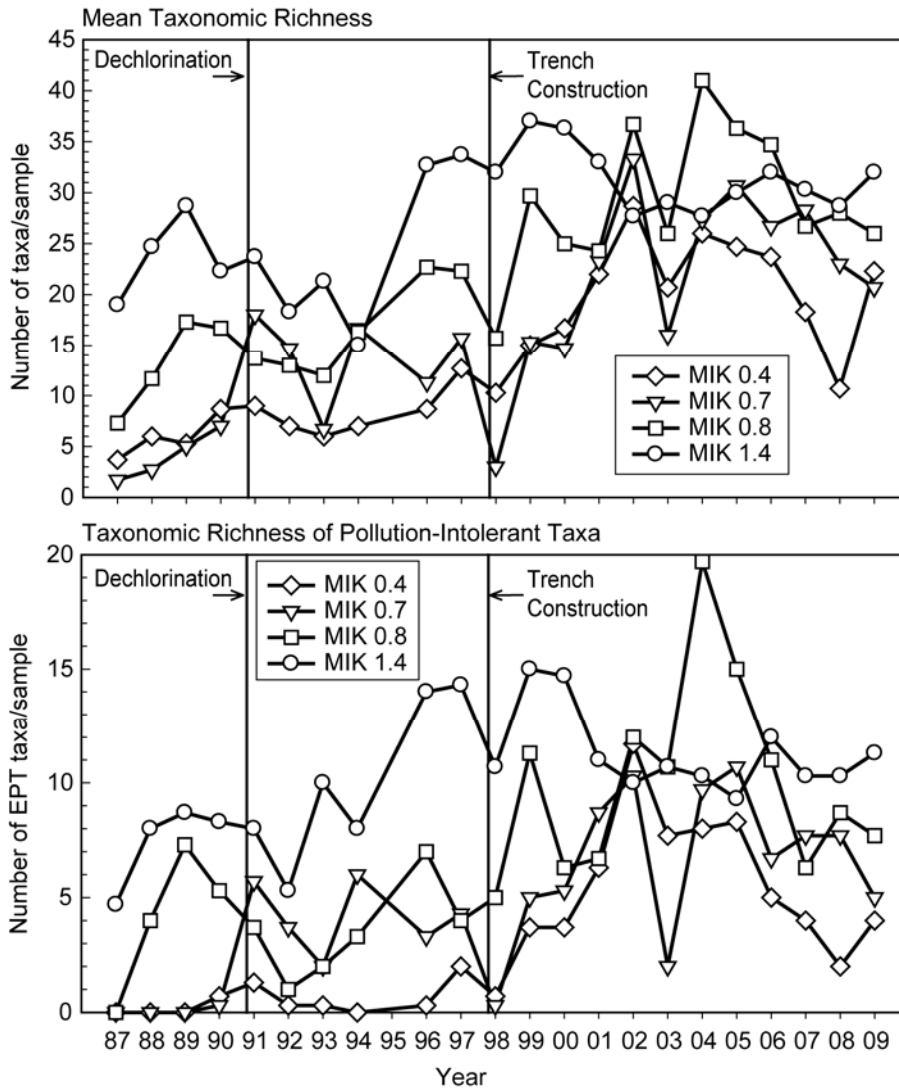
Fig. 3.53. Temporal trends in mean total taxonomic richness (top) and mean taxonomic richness of pollution-intolerant taxa (*Ephemeroptera*, *Plecoptera*, and *Trichoptera*, or EPT) in Mitchell Branch based on samples collected with ORNL protocols in April of each year, 1987–2009.
